**Re-tech PV**®

PV FAILURES CATALOG

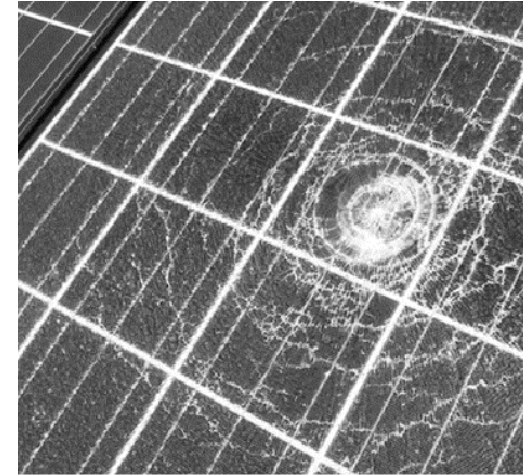
BROKEN GLASS

No value at all, panel is recycled.

Moisture enters and affects PV cells, expanding the damaged glass surface. Only option is to recycle the panels.

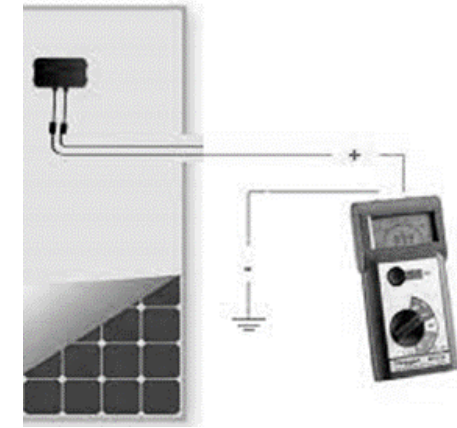
ISOLATION ERROR

Depends on the level of the isolation error.

A PV isolation fault is usually an earth fault on the DC side (the PV panels side) of the system which is usually caused by moisture ingress or damage to the system or the panel.

1. Low
2. Medium
3. High

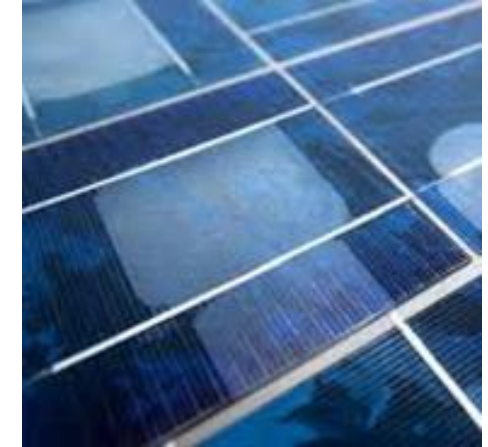
DELAMINATION

Delamination of a PV panel is the detachment, even if partially, of the encapsulant from the glass or the backsheet.

Different types and levels:

1. Bubbles inside modules.
2. Low isolation resistance.
3. Ribbon / busbar corrosion.
4. Forming a continuous path between any part of the electrical circuit and the edge of the PV panel.

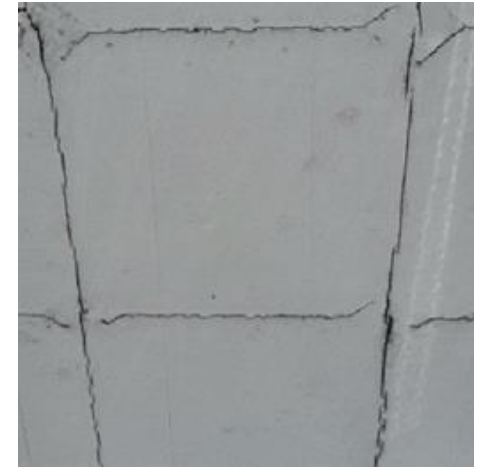
BACKSHEET CRACKS

Backsheet cracks is the degradation of the outermost “layer” of a PV panel and occurs on different stages.

1. Not visible yet, backsheet gets porous.
2. Beginning of cracks — light impact.
3. Full cracks around the cells.
4. Backsheet desintegrates.

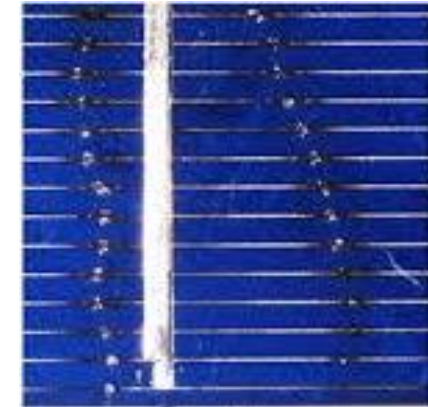
SNAIL TRAILS

Snail trails are discoloration of the PV panel, which builds up over years of power production on the field. Moisture can enter through the backsheet and diffuse to the cell surface.

Different levels

1. 1-3 cells affected.
2. 4-6 cells affected.
3. More than 6 cells with snail trails.

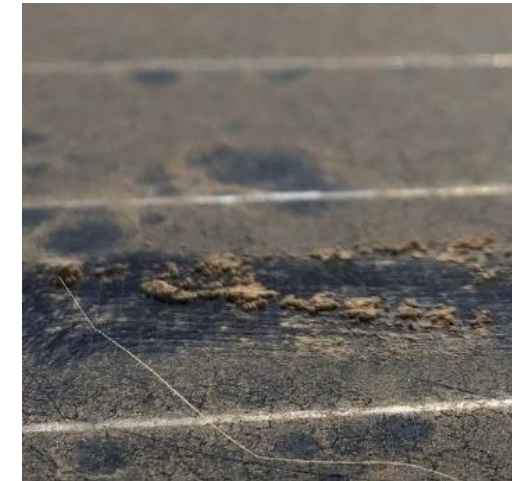
DUST BUILD-UP

Accumulation of dust on
the surface of PV panel.

Reduces the glass cover transmittance
and hence decreases the amount of
solar irradiation reaching the cells.

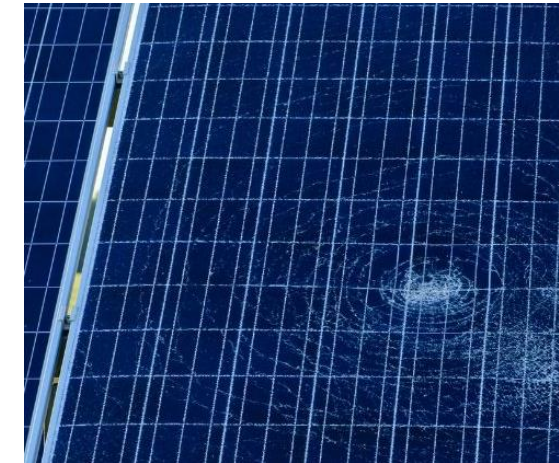
CRACKED CELLS

They are triggered by mechanical and chemical environmental factors causing stress to the panel during operation

Further stress factors are geared to the thermal cycles of the cells involving contracting, expanding and flexing metal contacts, solder and wire interconnects.

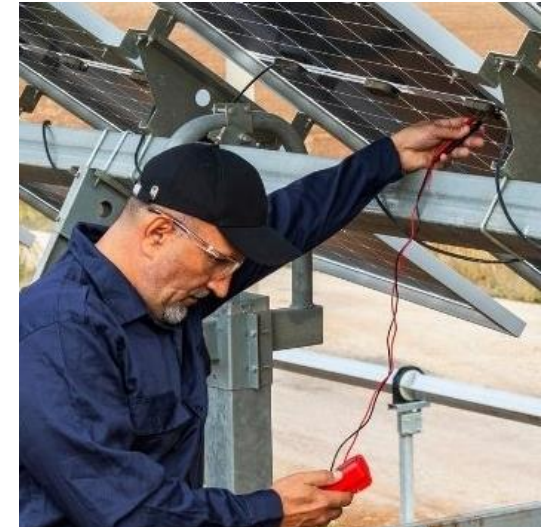
POOR STRING CONNECTION

Failures due to improper installation and operating stress are both avoidable.

Inadequate wire terminations, undersized conductors, environmental conditions that are outside of the equipment rating, inadequate protection from surge voltage and inadequate protection from physical damage.

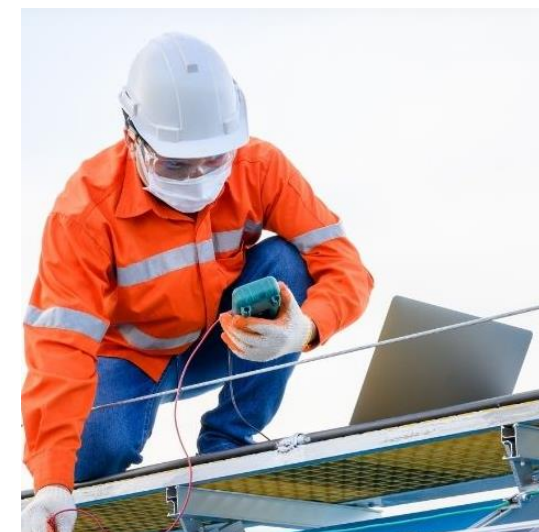
POTENTIAL INDUCED DEGRADATION

Potential induced degradation (PID) is a performance degradation in crystalline PV panels.

Caused by so called stray currents. This effect may cause power loss of up to 30 percent.

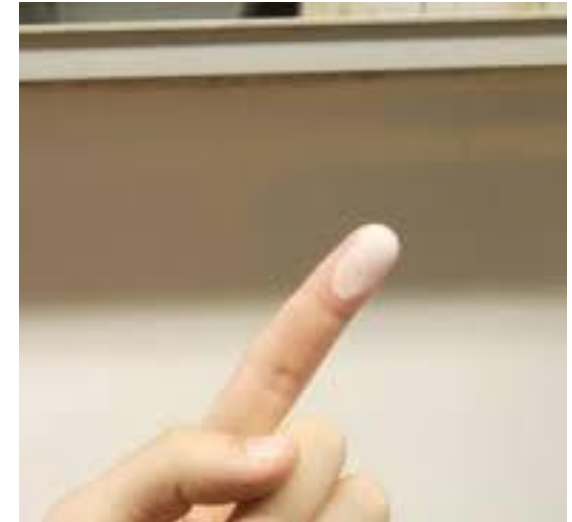
CHALKING

Polymer degradation in paints and coatings affecting reliability and performance.

Backsheet chalking is a failure mode of field exposed PV panels and is observable as a white powder on the outer backsheet layer.

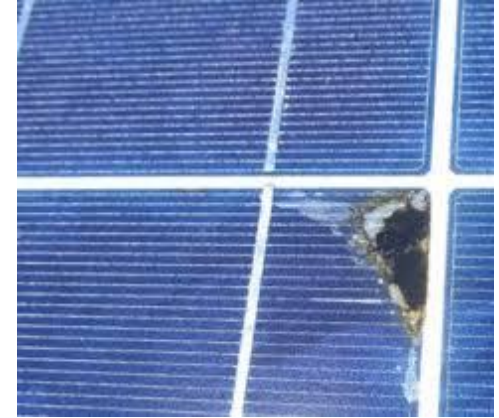
HOT SPOTS

Hot spot heating occurs in a PV panel when its operating current exceeds the reduced short circuit current (I_{sc}) of a shadowed or faulty cell or group of cells.

When such a condition occurs, the affected group of cells is forced into reverse bias and dissipates power, which can cause local overheating with different levels.

1. 1-3 cells affected.
2. 4-6 cells affected.
3. More than 6 cells with hot spots.

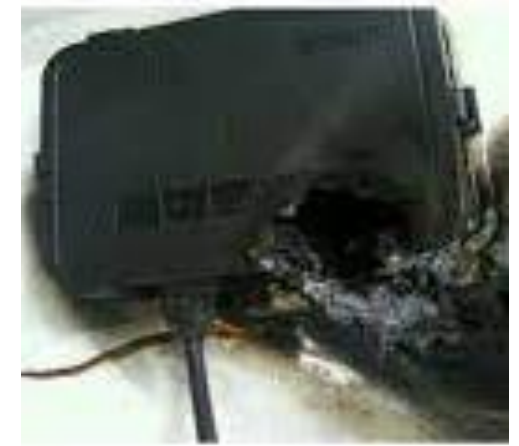
JUNCTION BOX

The junction box of PV panels fails in the field mainly because of fault current passing through the Junction box.

The main failures of Junction boxes are:

1. Burnt bypass diode.
2. Burnt off junction box.
3. Lost connection.
4. Malfunction.
5. Connection cable cut / broken.

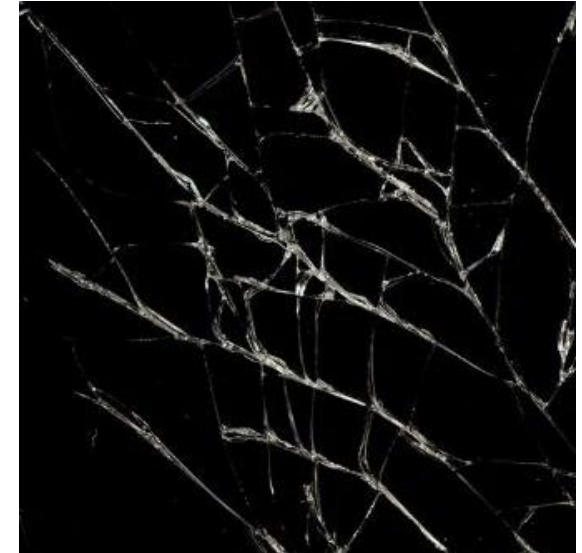
MICRO CRACKS

Micro fractures, also known as micro cracks.

The silicon used in the PV cells is very thin and expands and contracts due to thermal cycling. During the day, the solar panels expand because of higher temperatures.

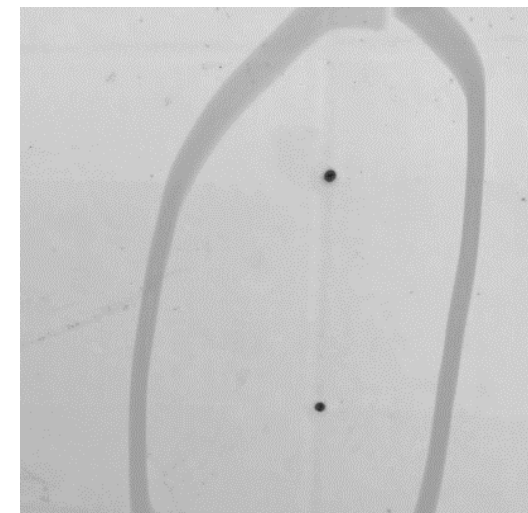
HOLES

Different types of holes.

Moisture enters and affects PV cells.
Holes tend to expand and get bigger.

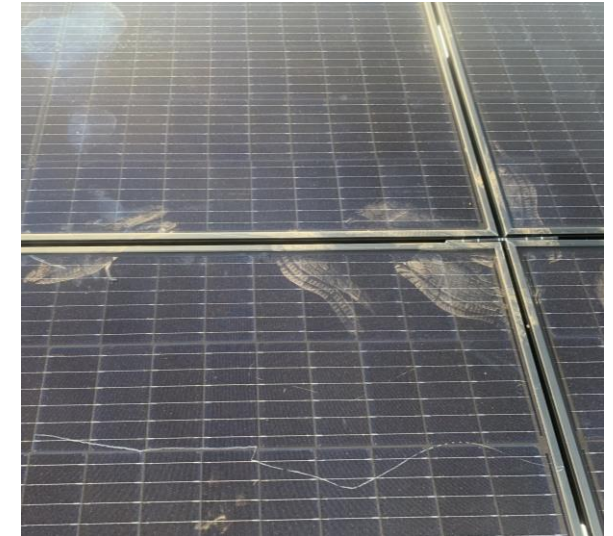
SCRATCHES

Damage or scratches will result in a reduction of efficiency.

The wrong cleaning tools and improper cleaning methods can scratch PV panels or make the glass cloudy.
